SUBJECT John Anglin, Clarence Anglin and
Frank Lee Morris Escape from Alcatraz

FILE NUMBER 76-26295

VOLUME NUMBER Enclosures 76, 137, 155 and 179

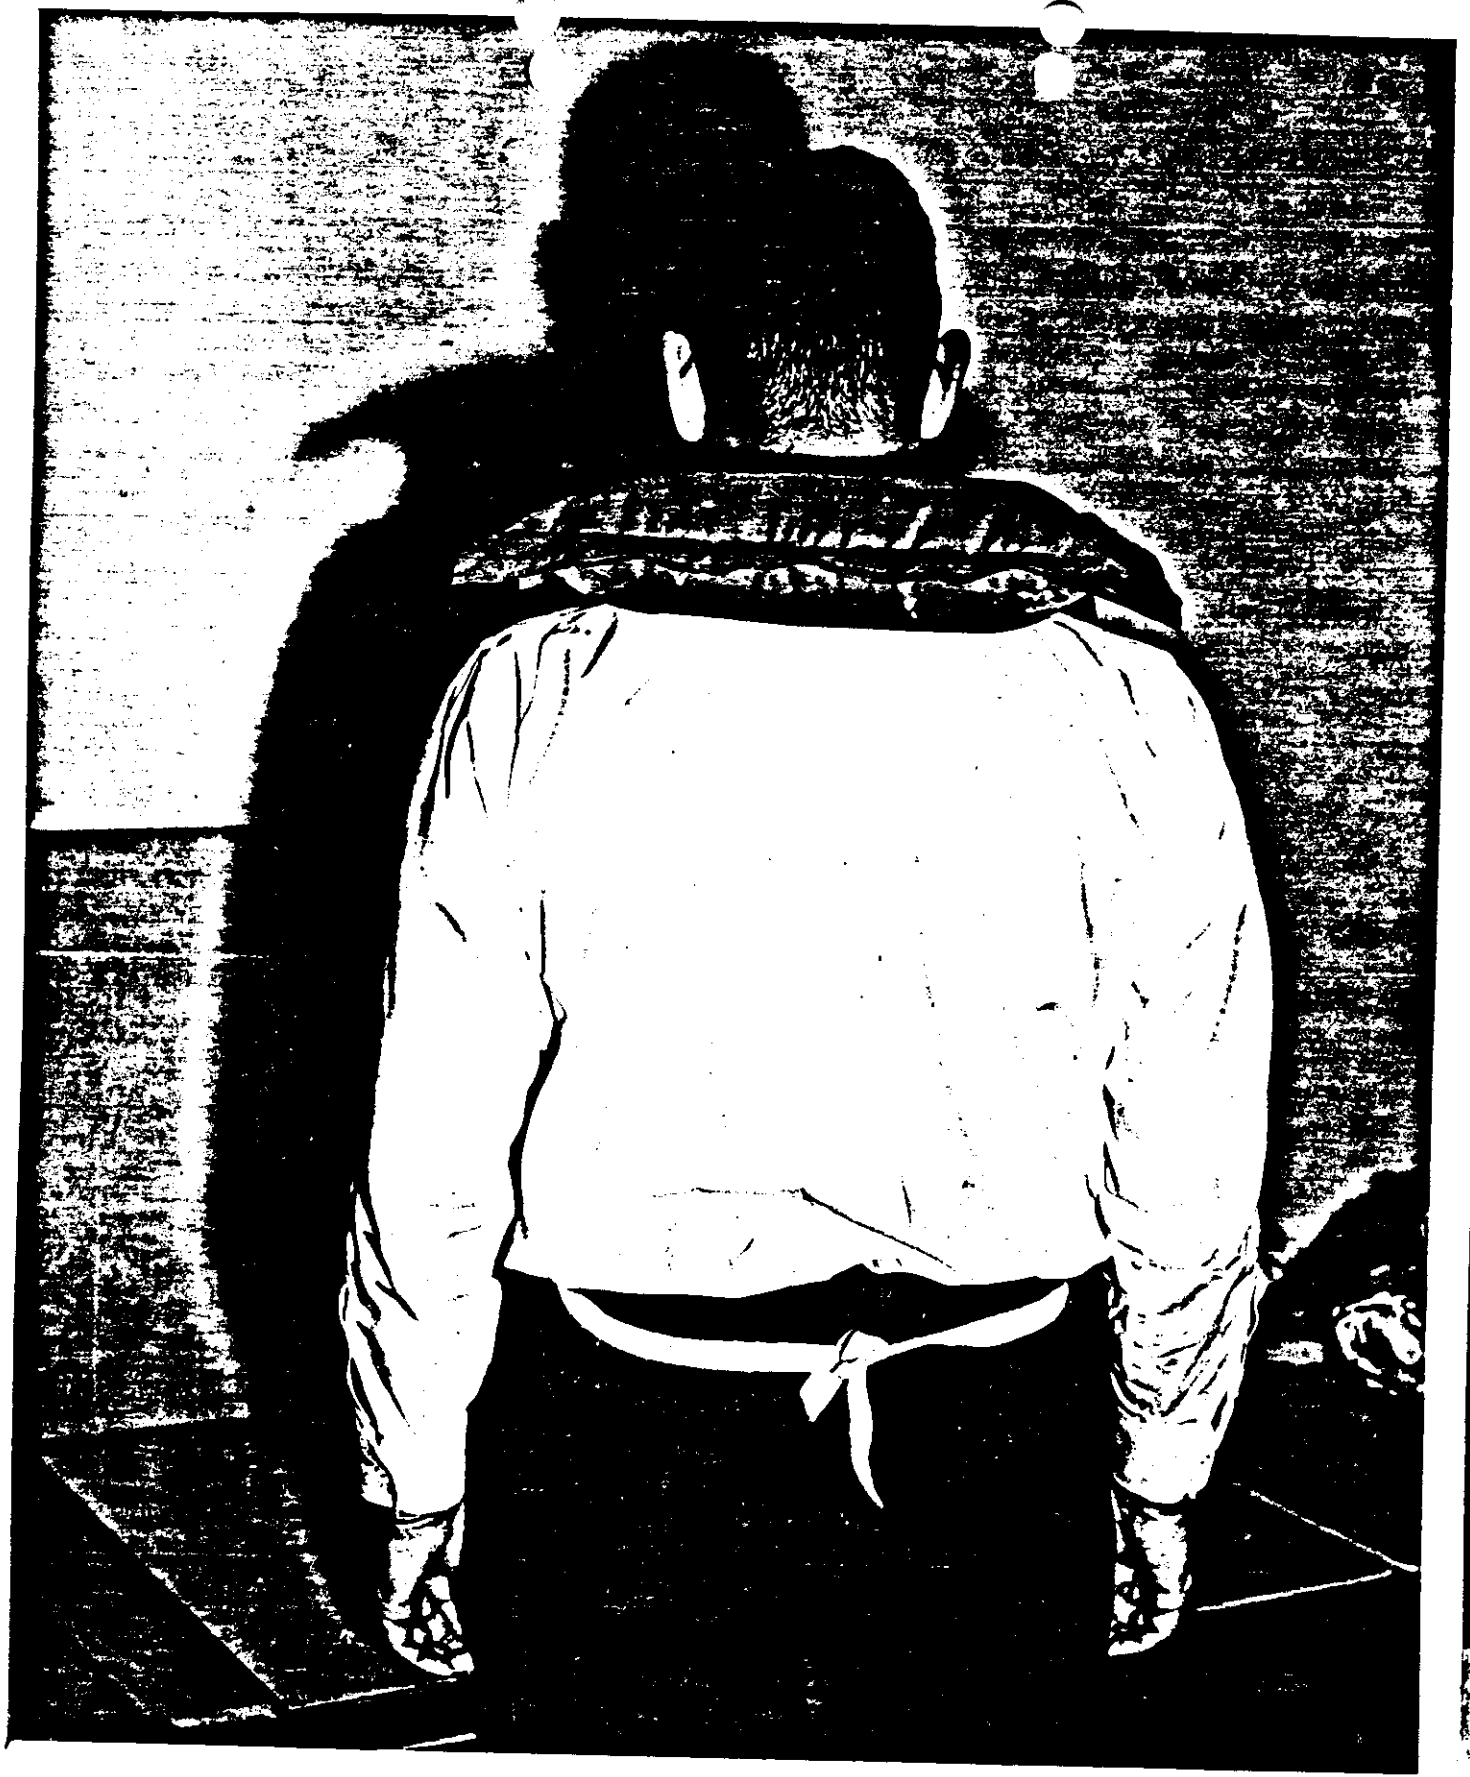
Rear view of yoke type vest being modeled by Special Agent.

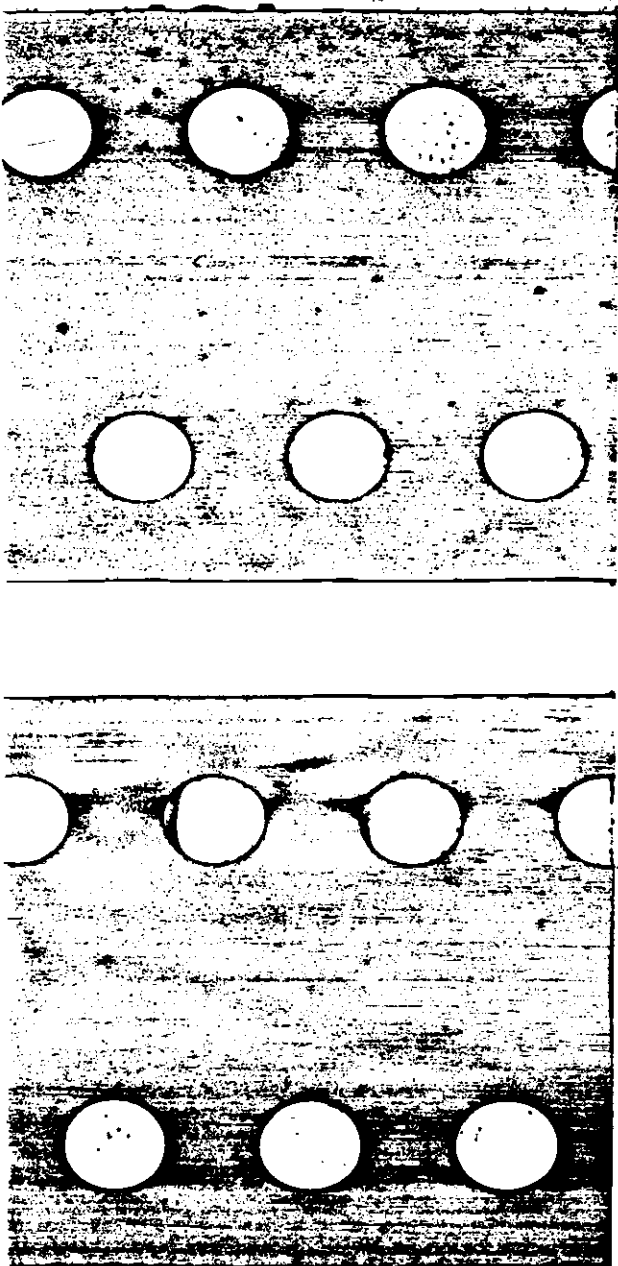
Concrete replica: this is the reproduced utility wall surface made to replace the concrete removed in order to avoid detection by a guard check along the utility corridor. This concrete was applied to hard board.

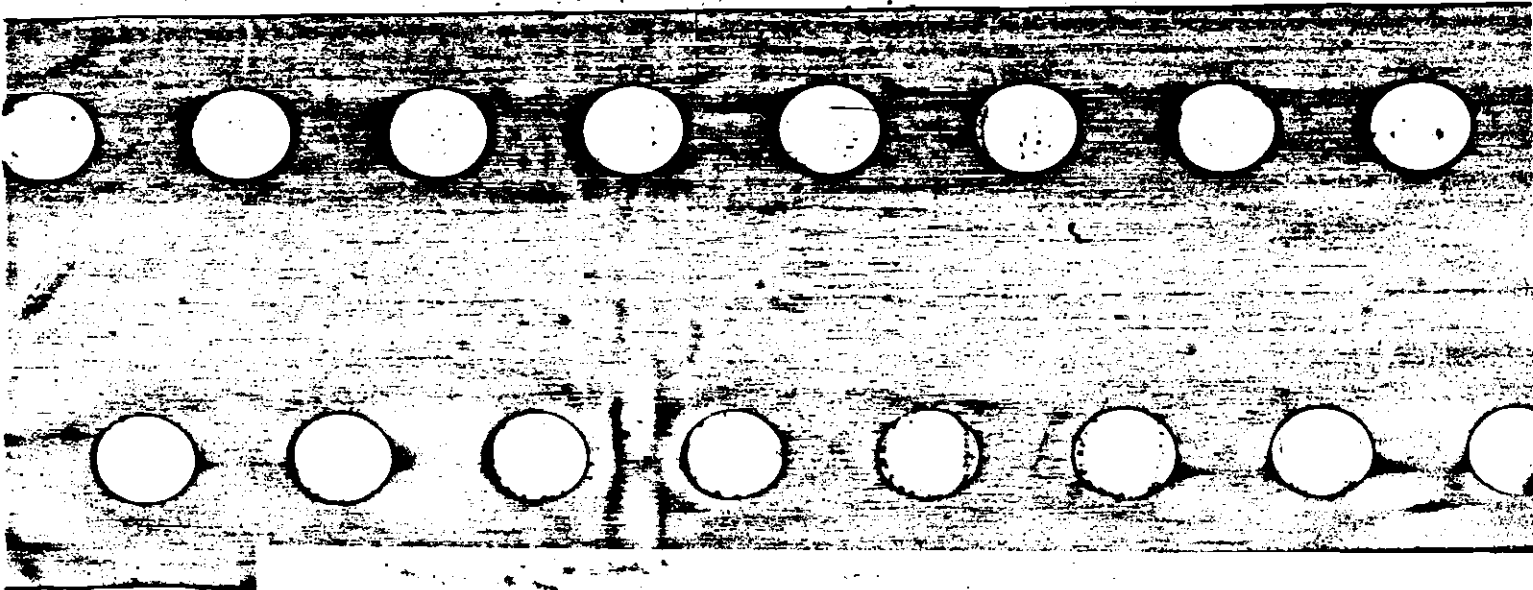
Rear view of concrete replica showing hard board. Note the wire hooks which were used to draw the replica into place from the inside of the cell.
